REPORT OF FINDINGS

JERI GILL-MCKENZIE RESIDENCE

NOVEMBER 28, 2020

Property Address:
3424 Mount Washington Road
Ardmore, OK 73401

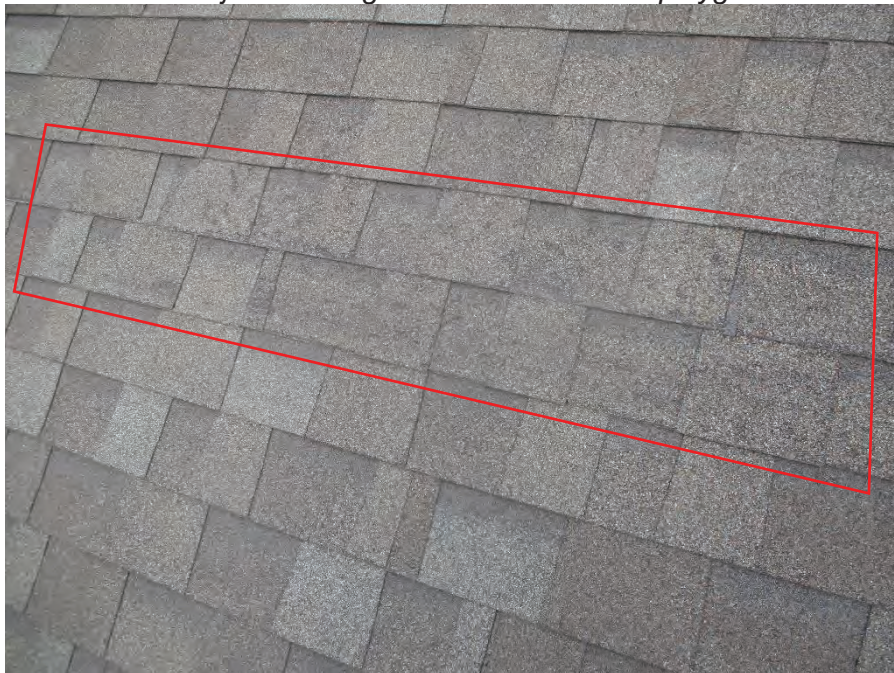
Photograph 44

Other areas of damage/granule loss were observed that exhibited a frequency and/or pattern not consistent with having resulted from impact from hail. On a west-facing roof slope, linear abrasions were observed at the end of each shingle course directly adjacent to a roof valley. At several locations on south-facing roof slopes, widespread and extensive granule loss was observed to occur on groupings/areas of shingles. However, groupings/areas of shingles directly adjacent and on the same roof slope did not exhibit a similar extent of granule loss. This pattern of damage suggested potential material deficiencies related to the shingles (i.e. a defective bundle of shingles). At the areas of granule loss, the exposed shingle mat exhibited a light gray coloration and the mat fibers were visible. These characteristics were consistent with long-term weathering of the exposed asphalt of the shingle and indicated that the granule loss was not a recent occurrence. (Attachment A, Photographs 39 through 44)

View of widespread granule loss on an area of shingles (within the red polygon). Note the relative absence of granule loss on the adjacent shingles outside of the red polygon.

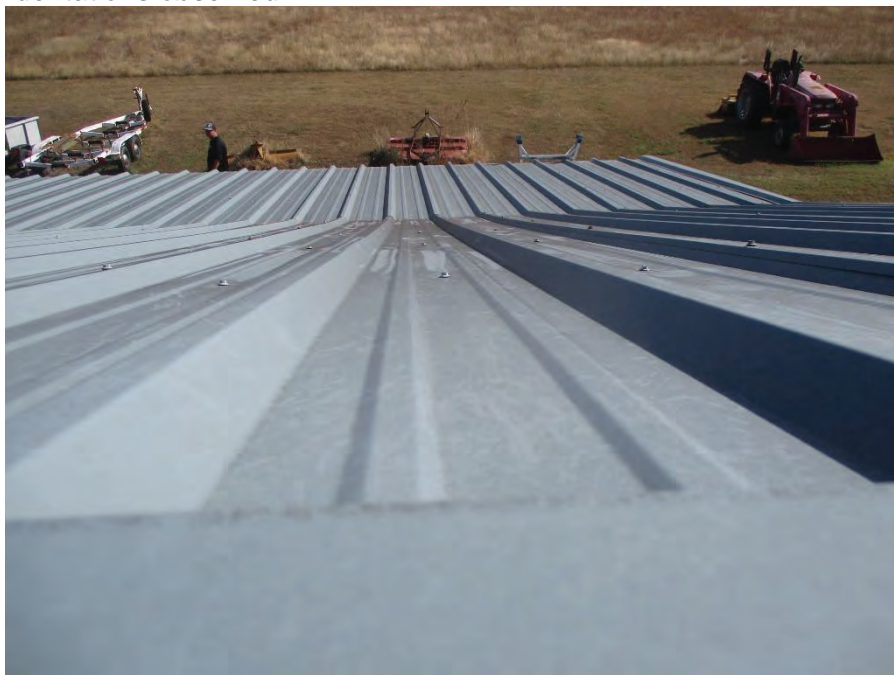
Photograph 47

Hail impact-related damage to a metal panel roofing system can be evidenced in a variety of ways depending on the size and energy of the hailstones that impact the roof. Typically, in the case of impact from hailstones measuring between approximately 1 and 2½-inches in diameter, the roof surface will exhibit a random distribution of dimple-like, aesthetic only indentations. It has been DEC's experience that these indentations are typically no smaller than approximately ½-inch in diameter and do not adversely affect the water-shedding capability or the anticipated service life of the roofing system. However, the indentations created by impact from hailstones measuring approximately 2½-inches or greater in diameter are typically deep enough to cause rupturing of the metal and spalling of the surface coating around the point of impact. In addition, impacts by hailstones of various sizes can result in disengagement/separation of the seams which can affect the water-shedding capability of the roofing system. DEC's visual and tactile inspection of the metal panel roofing system of the detached storage building found no evidence of damage consistent with impact from hail as described herein. (Attachment A, Photographs 45 through 50)

View of the representative condition of the metal panels on the east-facing roof slope of the storage building with no indentations observed.

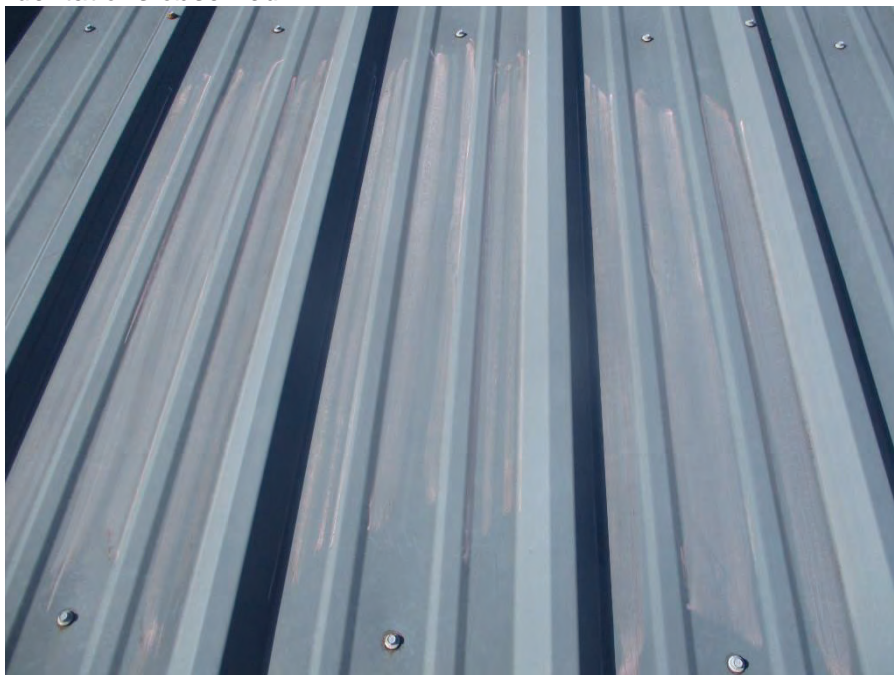
Photograph 48

View of the representative condition of the metal panels on the east-facing roof slope of the storage building with no indentations observed.

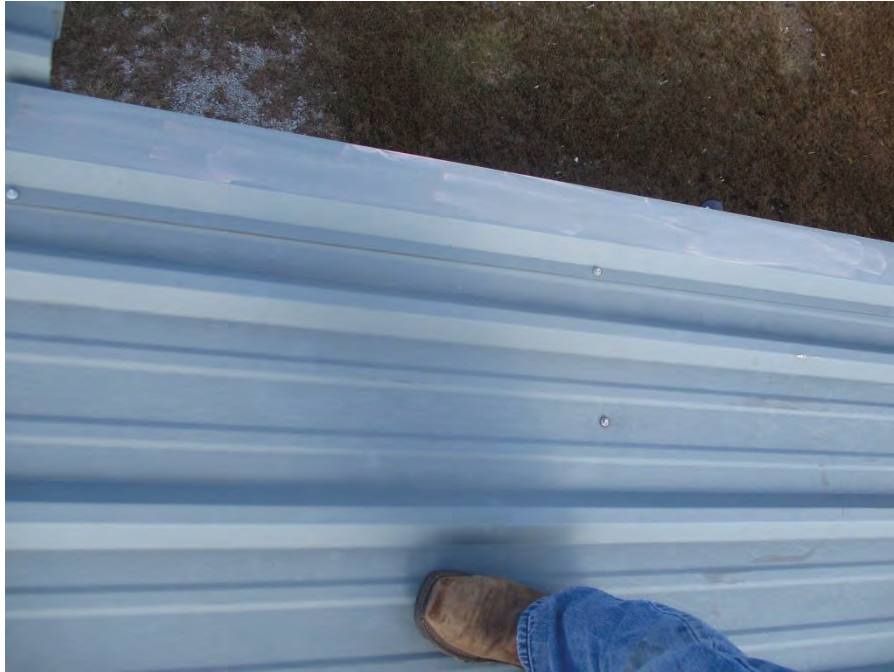
Photograph 49

View of the representative condition of the metal trim of the storage building with no indentations observed.

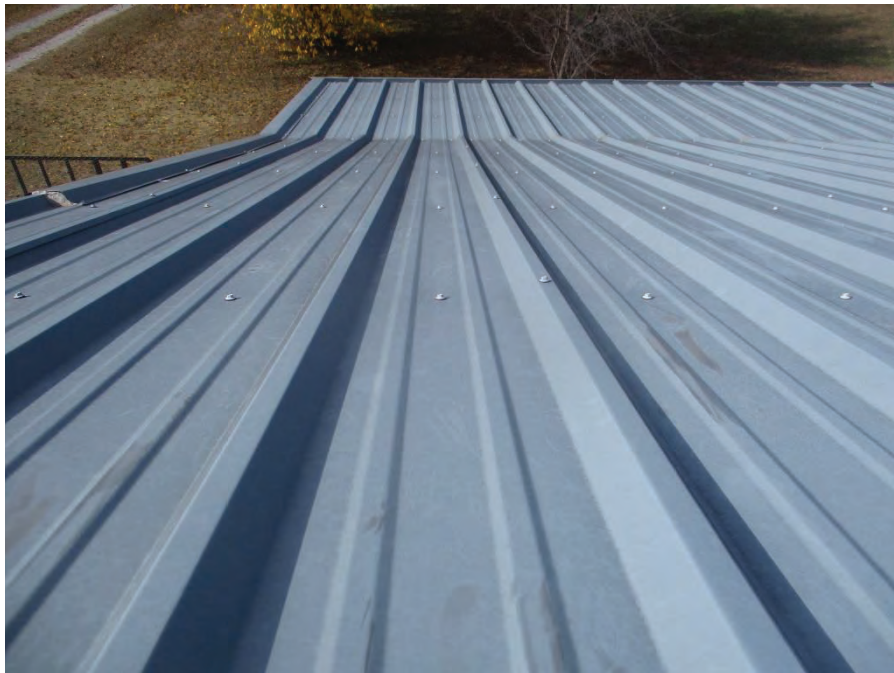
Photograph 50

View of the representative condition of the metal panels on the west-facing roof slope of the storage building with no indentations observed.
